Technical Memorandum
100 Sockanosset Cross Road
Cranston, Rhode Island

*Archaeological Cemetery Delineation: State
Farm Cemetery (Cranston Historical
Cemetery No. 60)*

January 7, 2020
Revised January 17, 2020

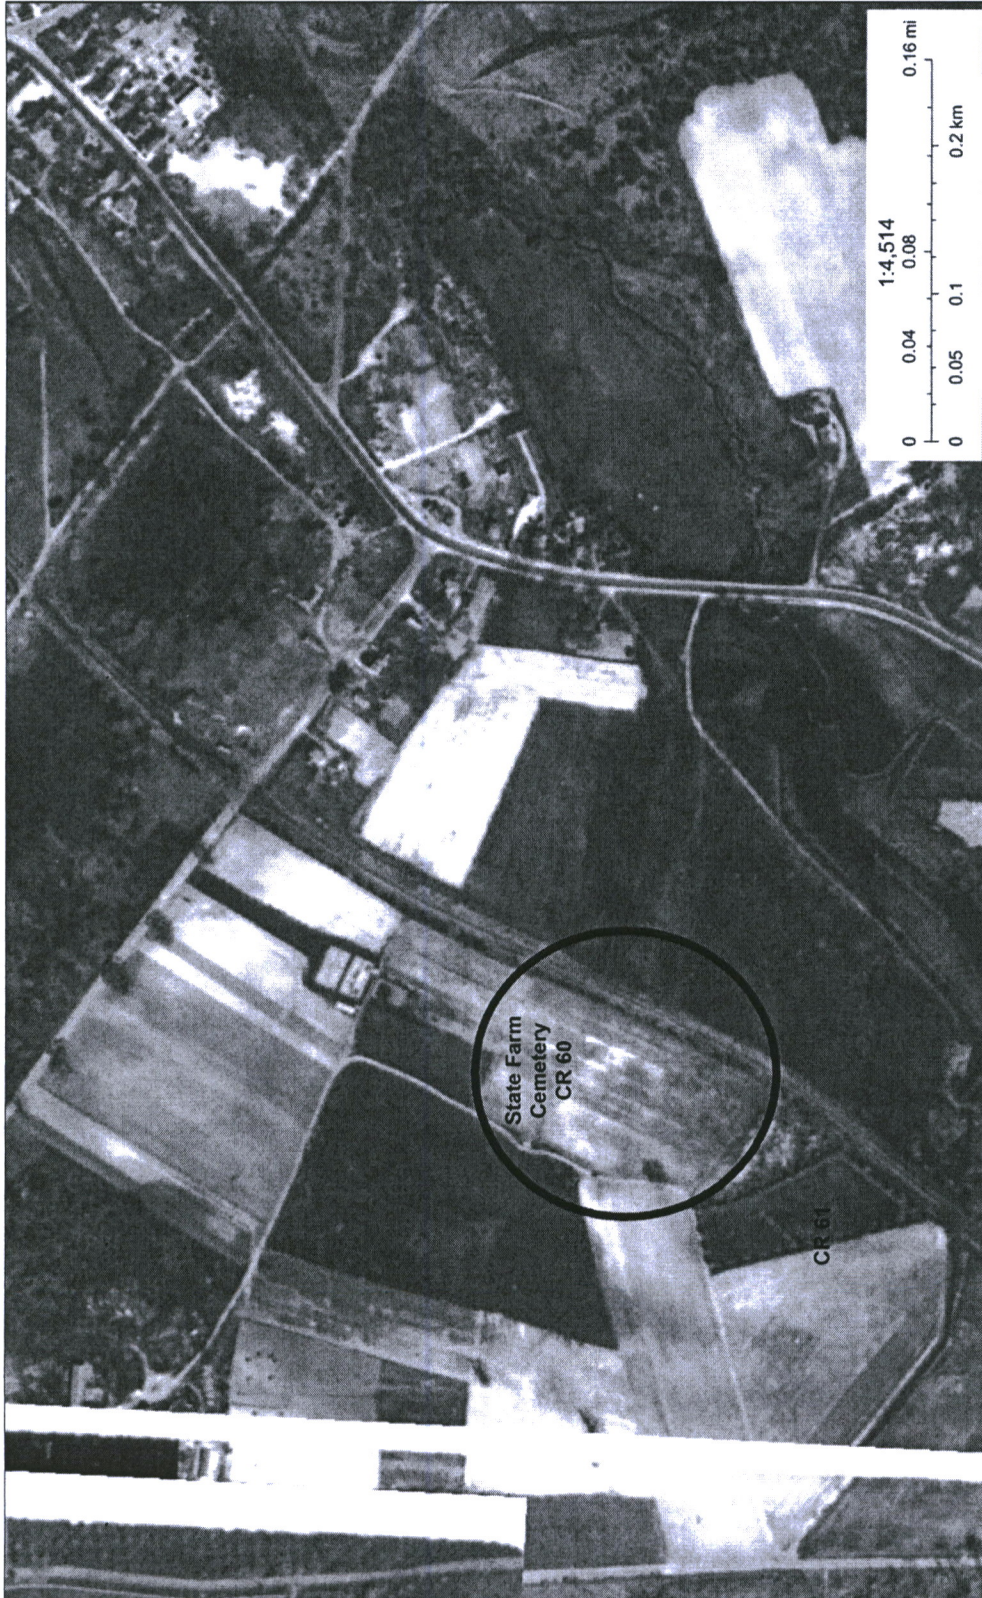
Figure 4. 100 Sockanosset Cross Road and State Farm Cemetery on the 1939 aerial photography of Cranston, Rhode Island.

The State Institution "Potters Field" coincides with the 3.4-acre parcel of land referred to as the State Farm Cemetery on the Latham (1887) *Map of the Rhode Island State Farm Cranston* and on the later 1895 Everts and Richard's map of Cranston (Figures 2 and 3). The absence of the cemetery on the D.G. Aerial photographs of Cranston demonstrate the cemetery was abandoned and forgotten not long after it ceased being used, as it appears to be an active farm field and is not visible next to State Institution Cemetery Site No. 1 (Cranston Historical Cemetery CR061) on the 1939 historical aerial photograph of Cranston (Figure 4).

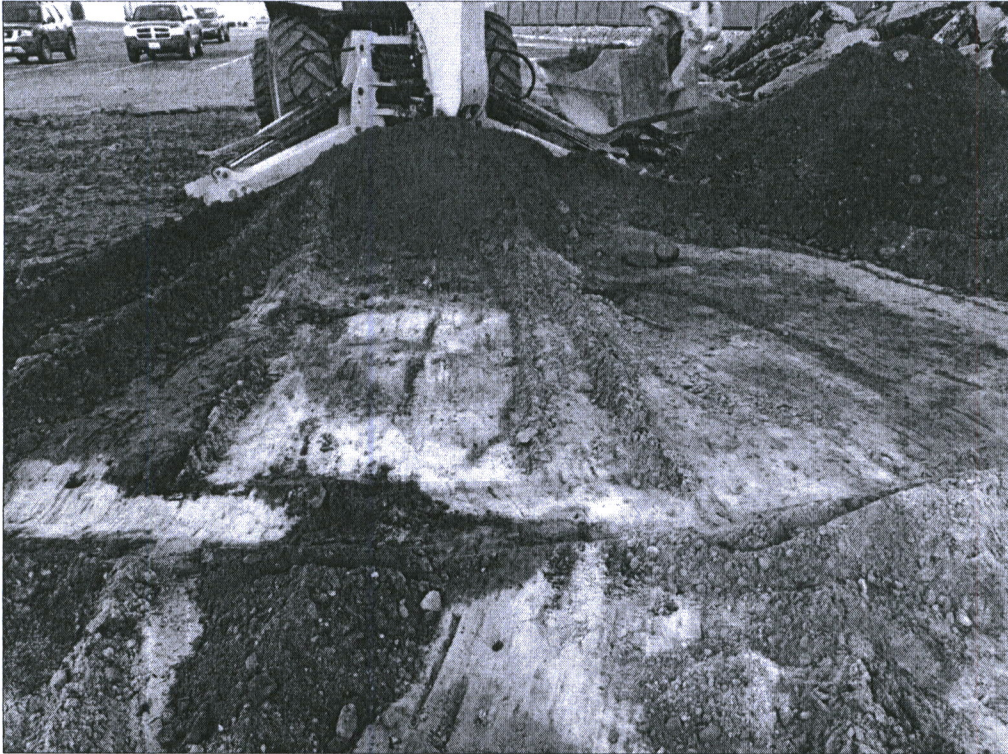
Figure 7. Asphalt and topsoil removal work in progress, view north.

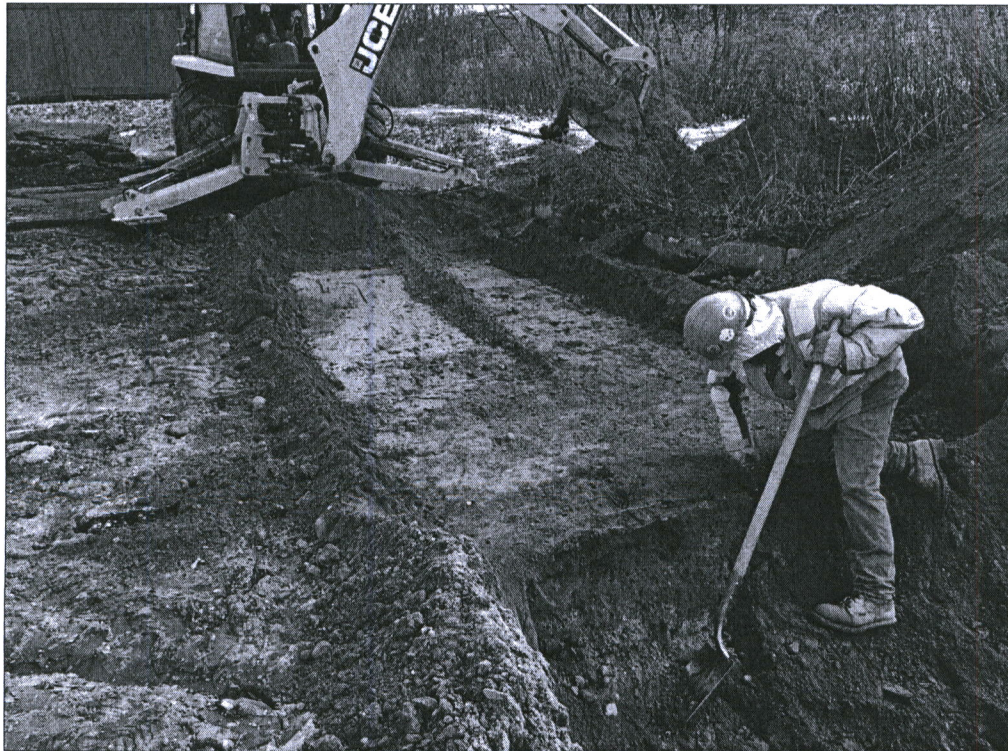
In cases where a cemetery’s boundaries are uncertain or unknown, machine-assisted topsoil removal can effectively identify unmarked graves and clearly delineate the limits of cemetery interments. Prior to the commencement of fieldwork, PAL support staff overlaid the historical boundaries of the State Farm Cemetery onto project design plans (Figure 5). Machine-assisted removal of asphalt and topsoil was then conducted within 25-feet (ft) of the State Farm Cemetery’s recorded northern boundary east and west of the small wetland drainage outfall within the southeast corner of 100 Sockanosset Cross Road (Figure 6). Parker construction provided a JCB 3CX backhoe equipped with a 4-ft wide grading bucket to remove asphalt, fills, and topsoils (Figure 7). PAL archaeologists directed and followed the backhoe using square shovels and masonry trowels to clean the topsoil/subsoil interface and inspect exposed trench floors for indications of graves or other cultural features (Figure 8). Identified remnant grave shafts were photographed and drawn to scale and the

Figure 8. PAL staff inspecting exposed ground surfaces during machine-assisted asphalt and topsoil removal at 100 Sockanosset Cross Road.

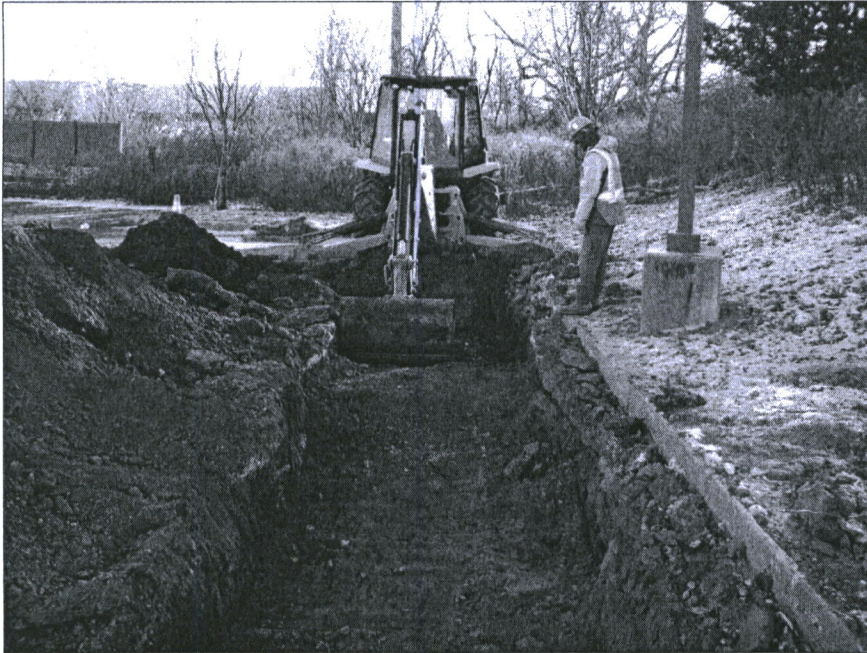
Machine-assisted topsoil established that the ground surfaces north of the State Farm Cemetery and west of the drainage outfall were disturbed by parking lot construction. Thick asphalt overlaid a prepared crushed pea stone gravel bed to approximately 20 centimeters below surface (cmbs) (Figure 9). The prepared parking lot surface is underlain by a mottled dark brown, dark gray, and dark yellowish brown sand and silt fill. Buried electric lines to power overhead lamps within the parking lot and drainage trenches transect PAL's test area. Mottle fills overlaid a gray clay C horizon subsoil at about 60 cmbs. The absence of an A horizon topsoils and B horizon subsoils within the 25-ft buffer show that much of the original soils from this area were graded and removed during previous construction. No grave shafts or mortuary artifacts were recovered from the State Farm Cemetery 25-ft protection buffer west of the drainage outfall.

Figure 9. 100 Sockanosset Cross Road west trench, view east.

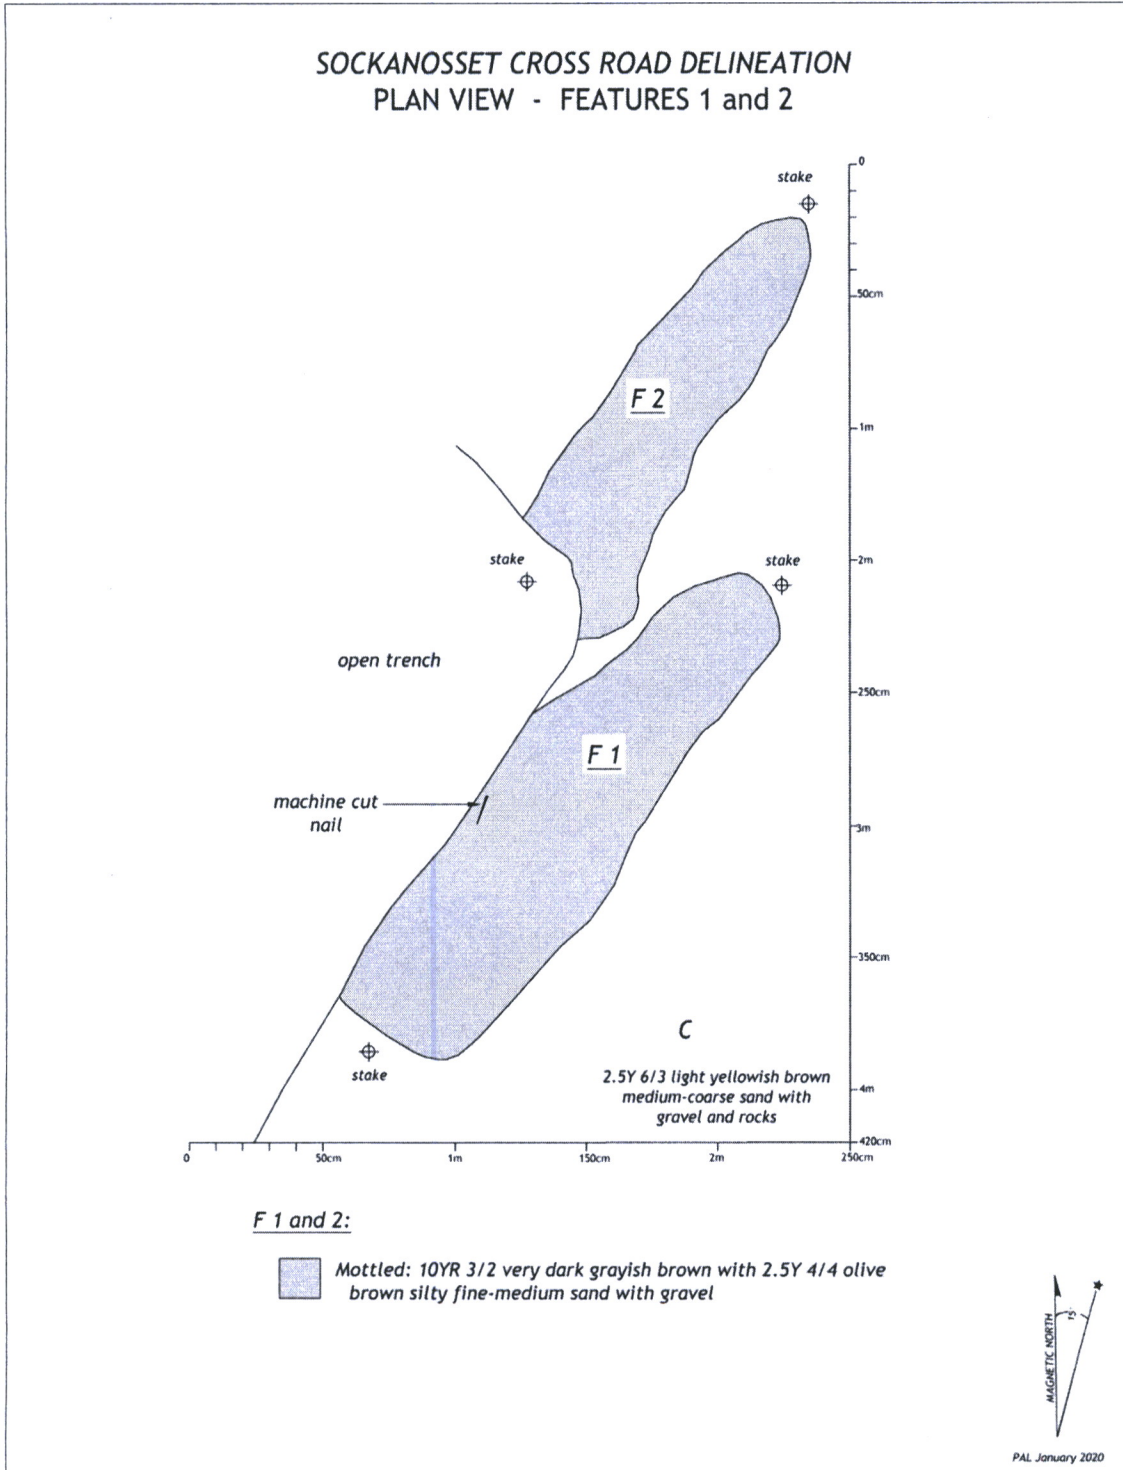
Ground surfaces beneath the asphalt exhibited varying degrees of disturbance within the State Farm Cemetery and 25-ft protection buffer east of the drainage channel in the southeast corner of the property. Cement curbing and asphalt overlaid fills that extended from 20 to 155 cmbs into natural light yellowish brown B₂ or dark gray C horizon subsoils. Natural soils were mixtures of silts and sands. PAL documented two remnant parallel grave shafts (Features 01 and 02) within this area (Figure 10). Grave shafts appeared as parallel rectangular outlines of mottled very dark grayish brown (10YR 3/2) and olive brown (2.5Y 4/4) silty fine to medium textured sands with gravel that intruded into the natural light yellowish brown (2.5Y 6/3) underlying subsoils (Figure 11). The exposed grave shafts ranged from 50 – 60 cm wide and 194 – 220 cm long. An examination of the profiles suggests that several feet of original topsoils had previously been removed from this area and that only 10–15 cm of these grave shafts remain. As these grave shafts are located within the defined boundaries of the State Farm Cemetery PAL did not excavate the identified grave shafts and their content is unknown. No burial markers were associated with either of these graves.

Figure 11. Plan of Grave shaft Features 1 and 2, 100 Sockanosset Cross Road.
